DELAWARE RIVER BASIN  
LEAVITT BRANCH, BRODHEAD CREEK  
MONROE COUNTY, PENNSYLVANIA

# SKYTOP DAM (MOUNTAIN LAKE)

PHASE I INSPECTION REPORT  
NATIONAL DAM INSPECTION PROGRAM

MARCH 1979

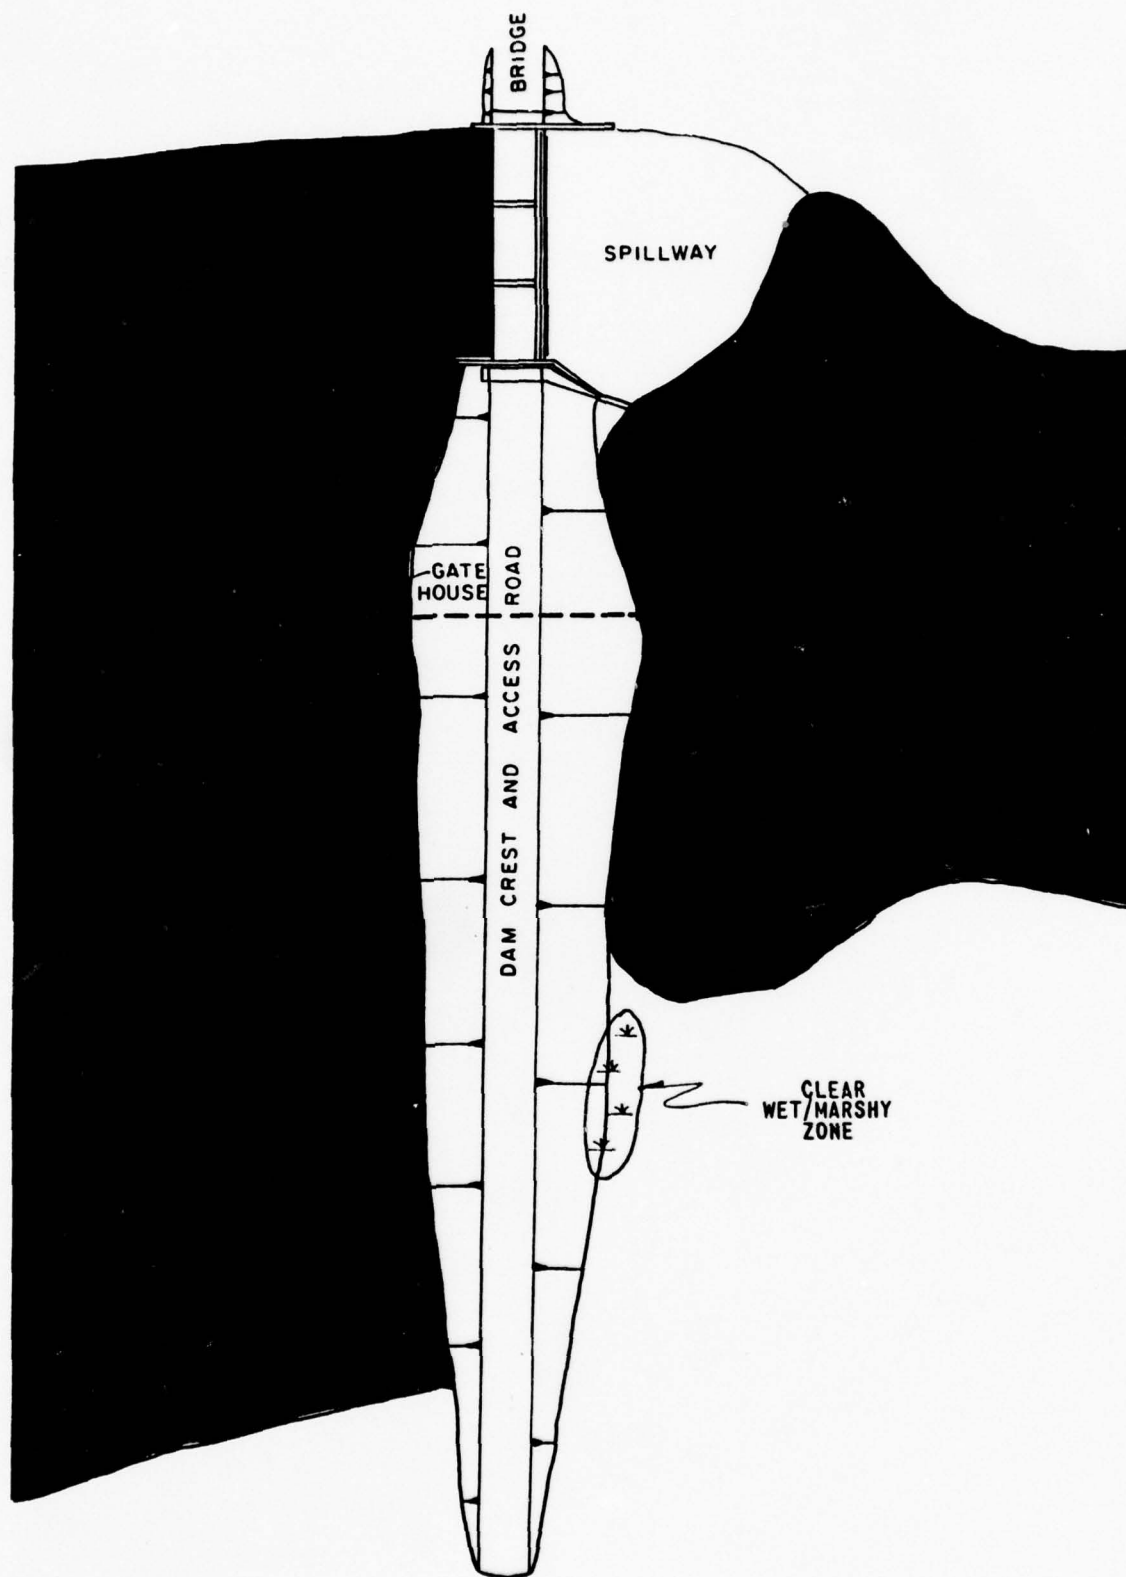
SEEPAGE LOCATION PLAN  
SHEET 5A OF 11

*Yes. A marshy zone was noted on the downstream side of the embankment near the toe of the right abutment. It appears that the area has been in this condition for many years and is stable. No action is recommended.*

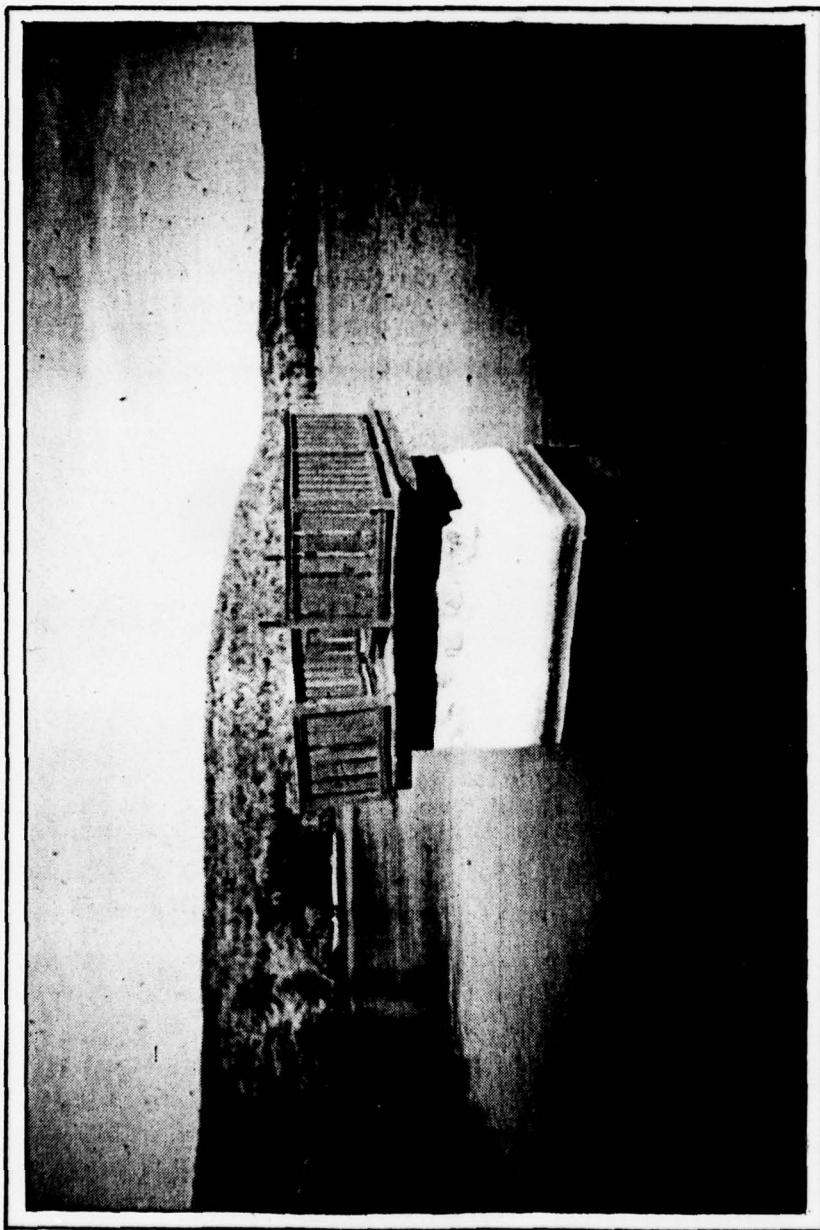
PHOTOGRAPH NO. 1

INTAKE TOWER

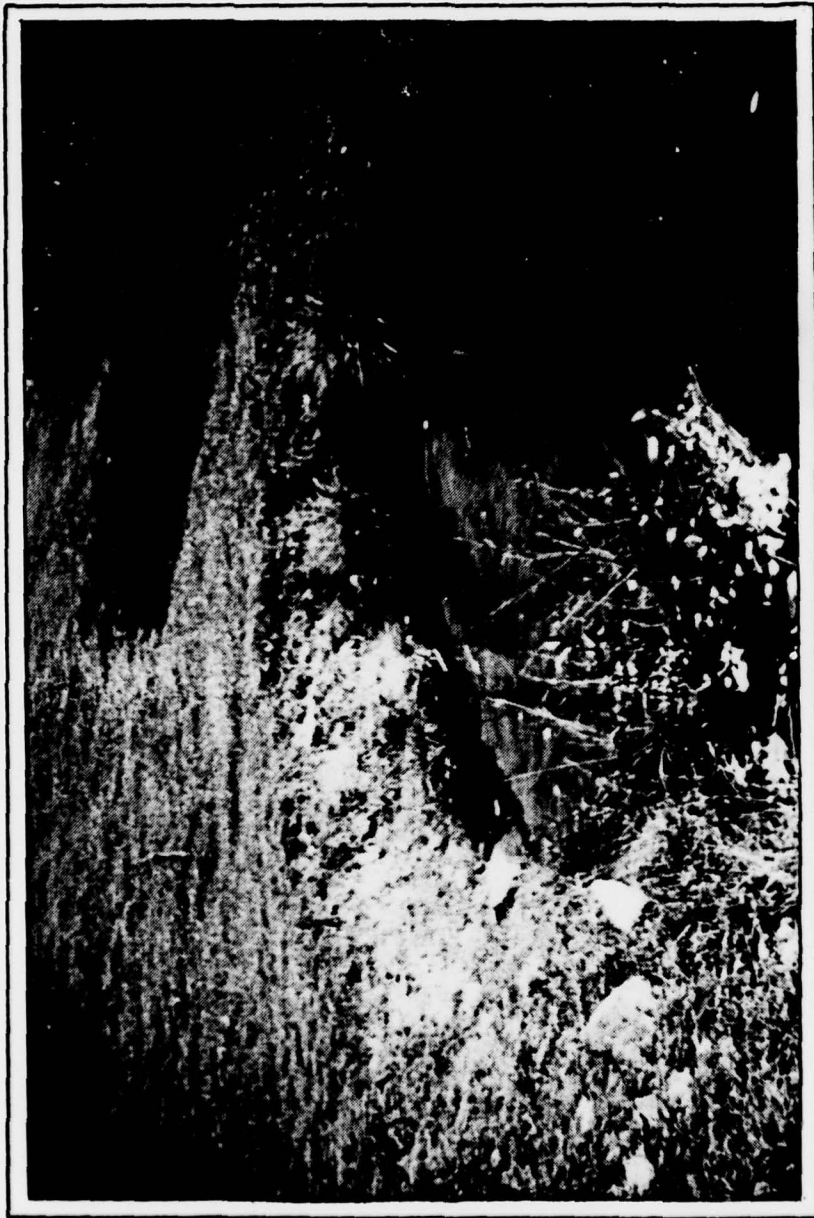
VIEW OF OUTLET SYSTEM AT DOWNSTREAM  
TOE. THE OUTLET PIPE DISCHARGES BELOW  
THE WATER LEVEL OF THE LOWER RESERVOIR  
(DOCTOR MAINE POND).

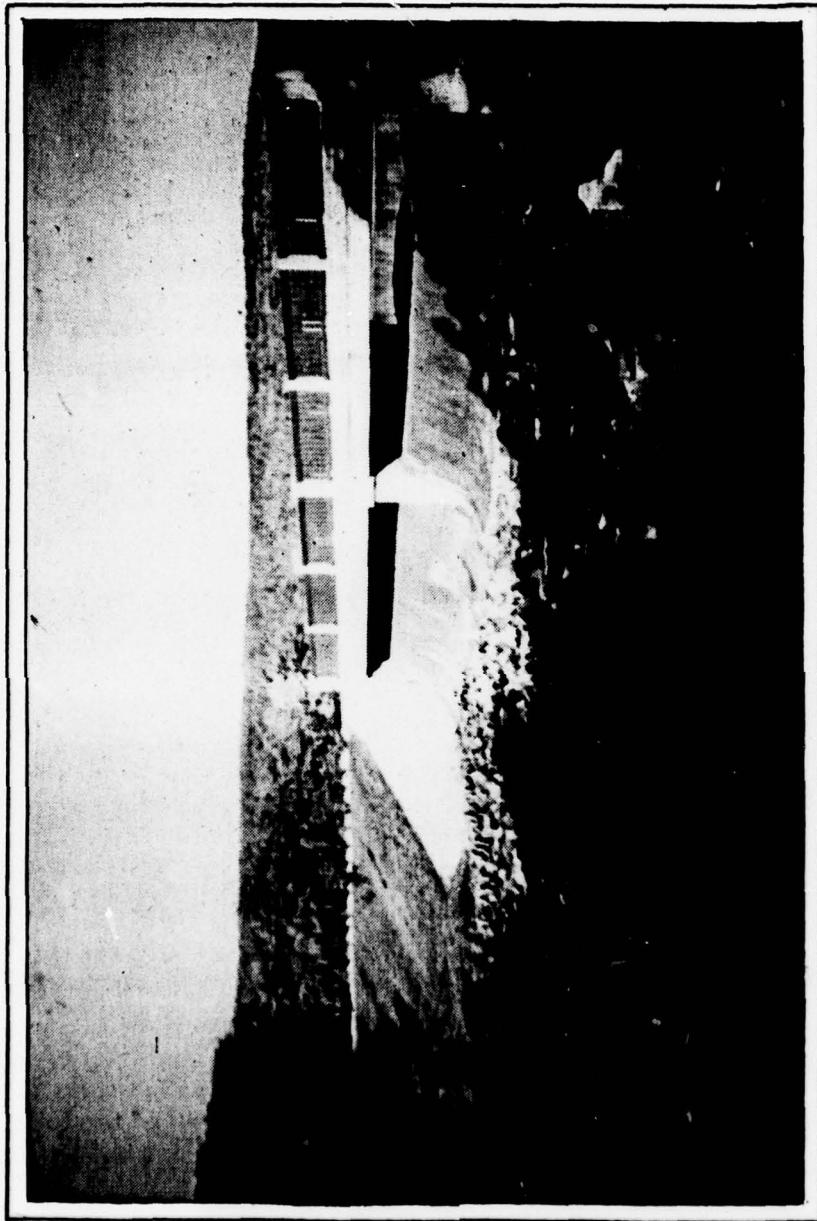
PHOTOGRAPH NO. 3

OVERVIEW OF SPILLWAY AND DISCHARGE  
CHANNEL.

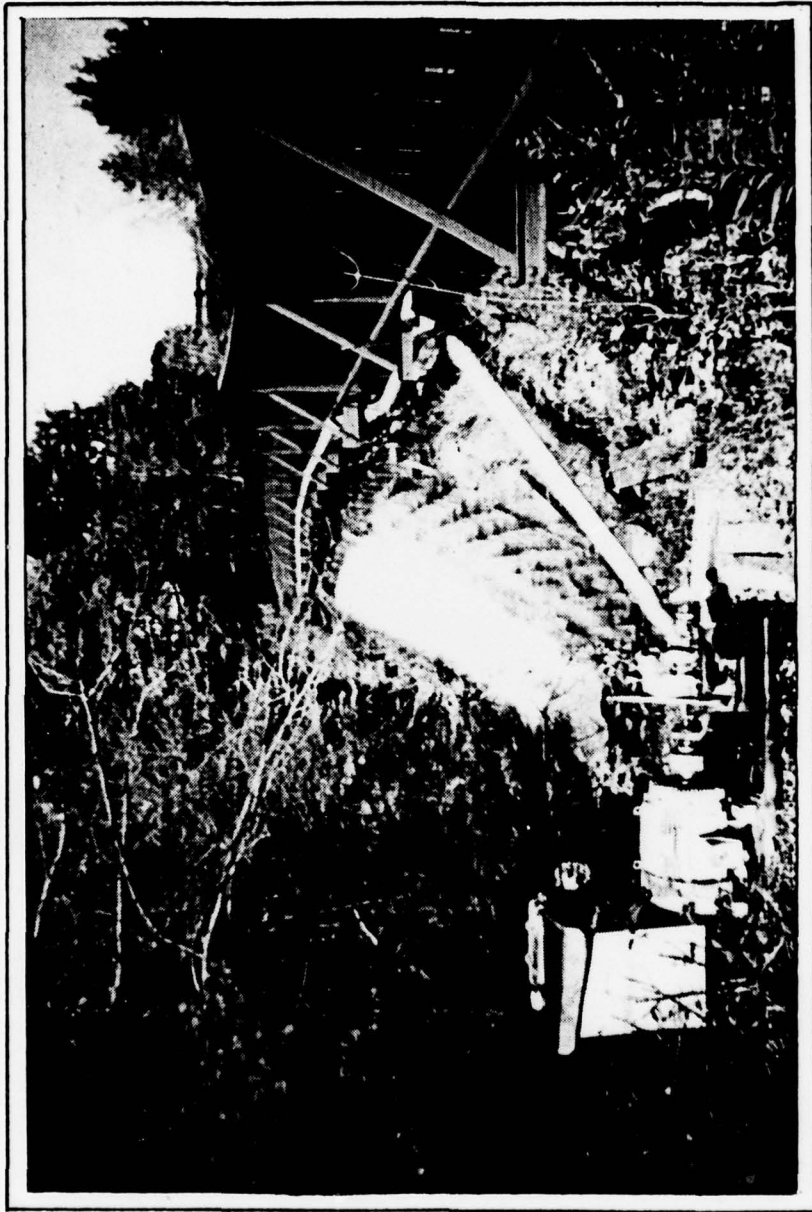
PHOTOGRAPH NO. 9

VIEW OF DOWNSTREAM SIDE OF NO. 10  
DAM.

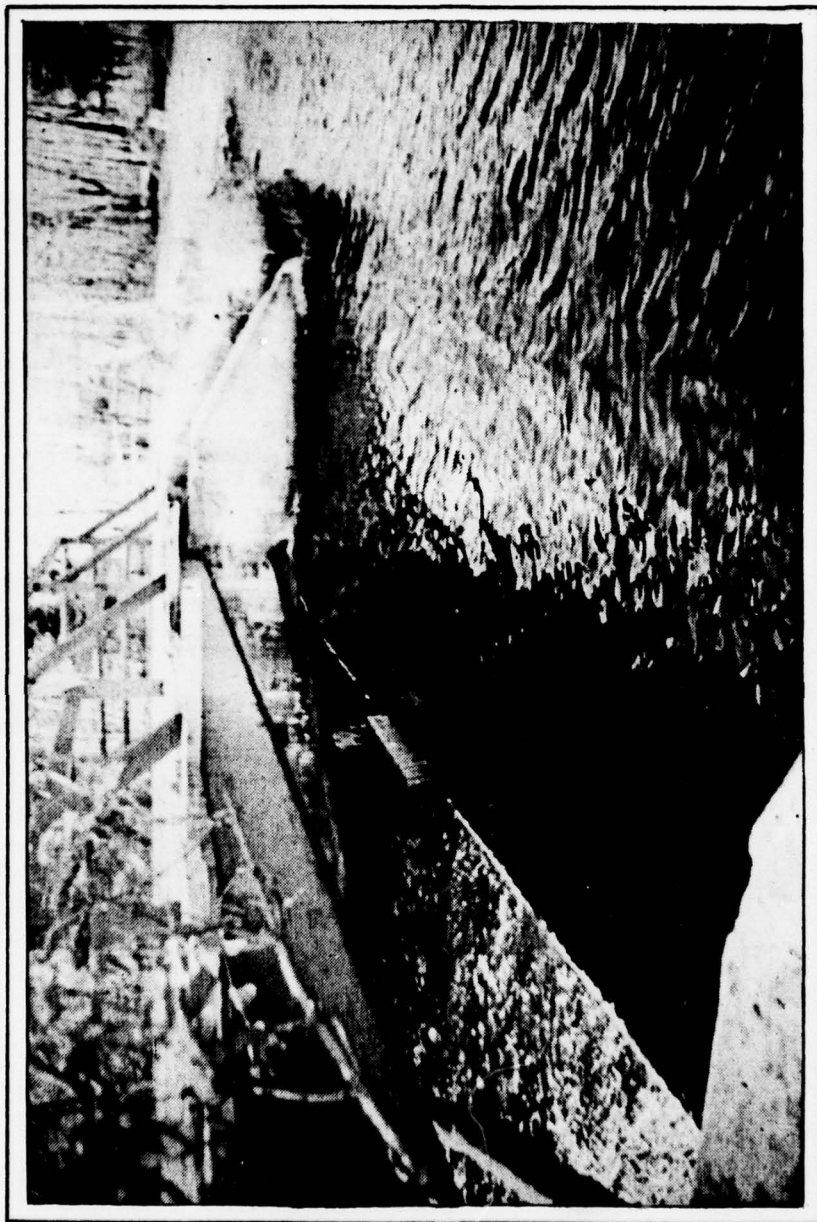
SPILLWAY OF LAKE IN THE CLOUDS.  
THE DAM AND RESERVOIR ARE  
LOCATED APPROXIMATELY 2.5 MILES  
UPSTREAM OF SKYTOP RESERVOIR.
